INDOOR AIR QUALITY ASSESSMENT

**Ipswich Public Library
44 School Street
Ipswich, Massachusetts**

Prepared by:
Massachusetts Department of Public Health
Bureau of Environmental Health
Emergency Response/Indoor Air Quality Program
August 2007

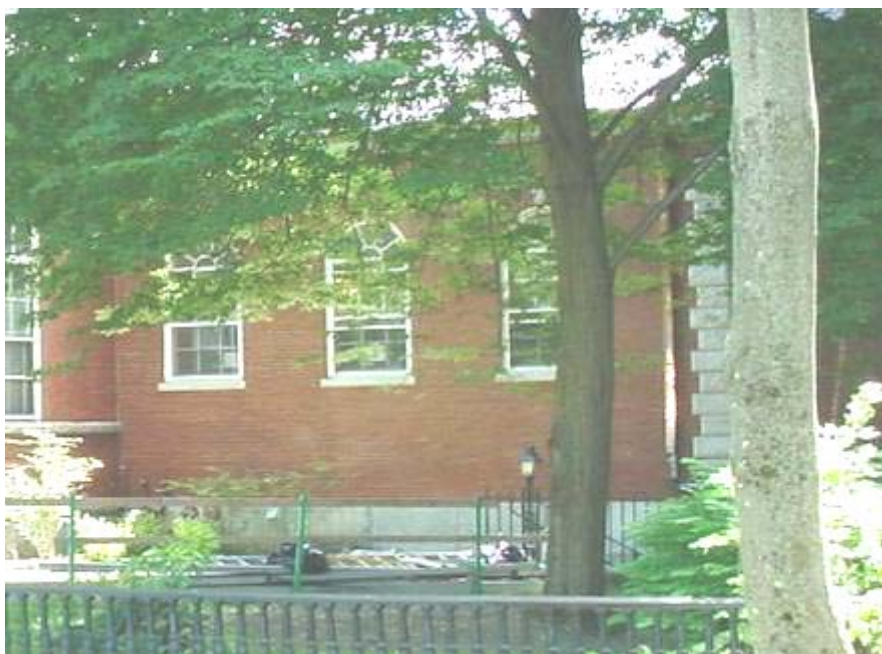
Picture 1

On June 22, 2007, Michael Feeney, Director of Emergency Response/Indoor Air Quality (ER/IAQ), made a visit to the IPL. The IPL was built in 1869 as a two-story, free-standing, red brick building. The first addition was constructed on the south wall of the building in 1940 (Picture 1). A second edition was added to the rear of the building in 1997 (Pictures 2 and 3). Windows are openable in a number of areas in the building.

First Addition Constructed on the South Wall of the Building in 1940

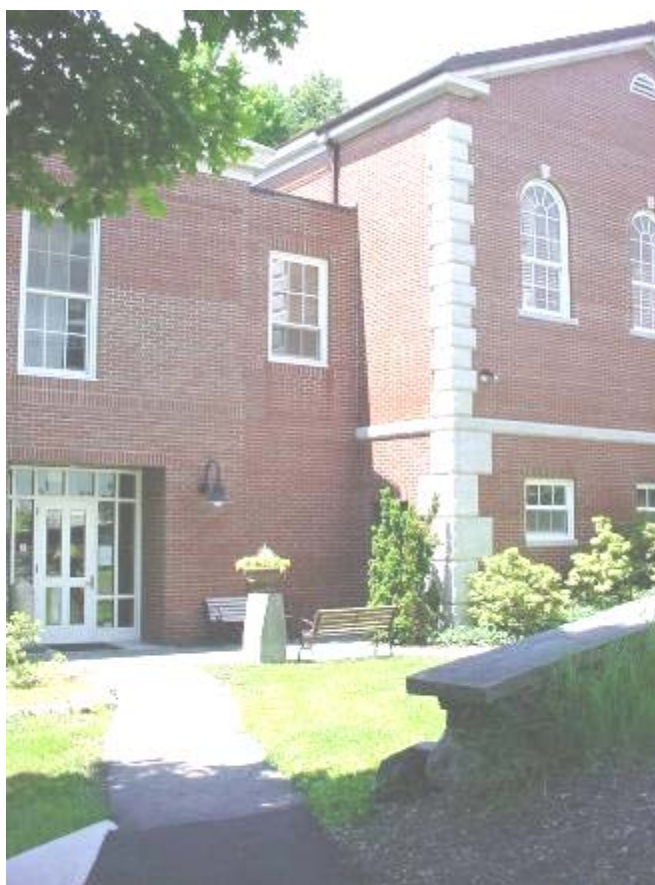
Picture 2

1997 Addition

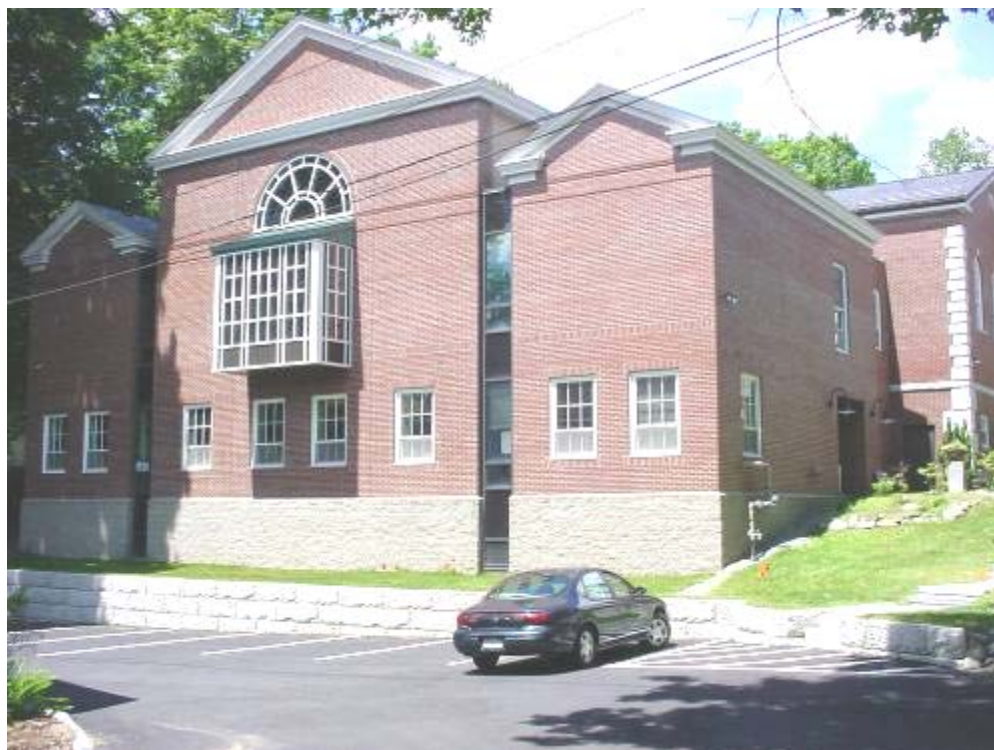
Picture 3

1997 Addition

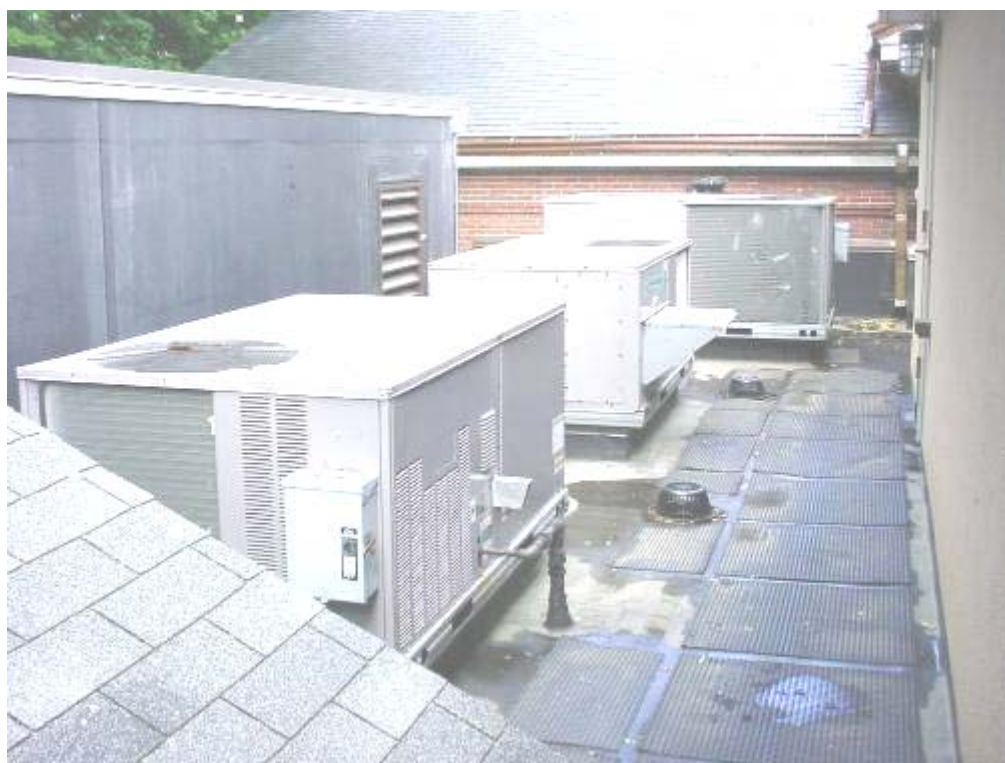
Picture 4

Ventilation is provided by a heating, ventilating, and air-conditioning (HVAC) system. Fresh air is supplied by rooftop-mounted air handling units (AHUs) (Picture 4). Fresh air is distributed to offices and other areas by ceiling and wall-mounted fresh air diffusers and returned to the rooftop units via ductwork. The Archive room has an AHU that does not introduce fresh air nor does it exhaust air. Therefore, normally occurring pollutants (e.g., carbon dioxide and water vapor) will tend to build-up in this area.

Rooftop AHUs

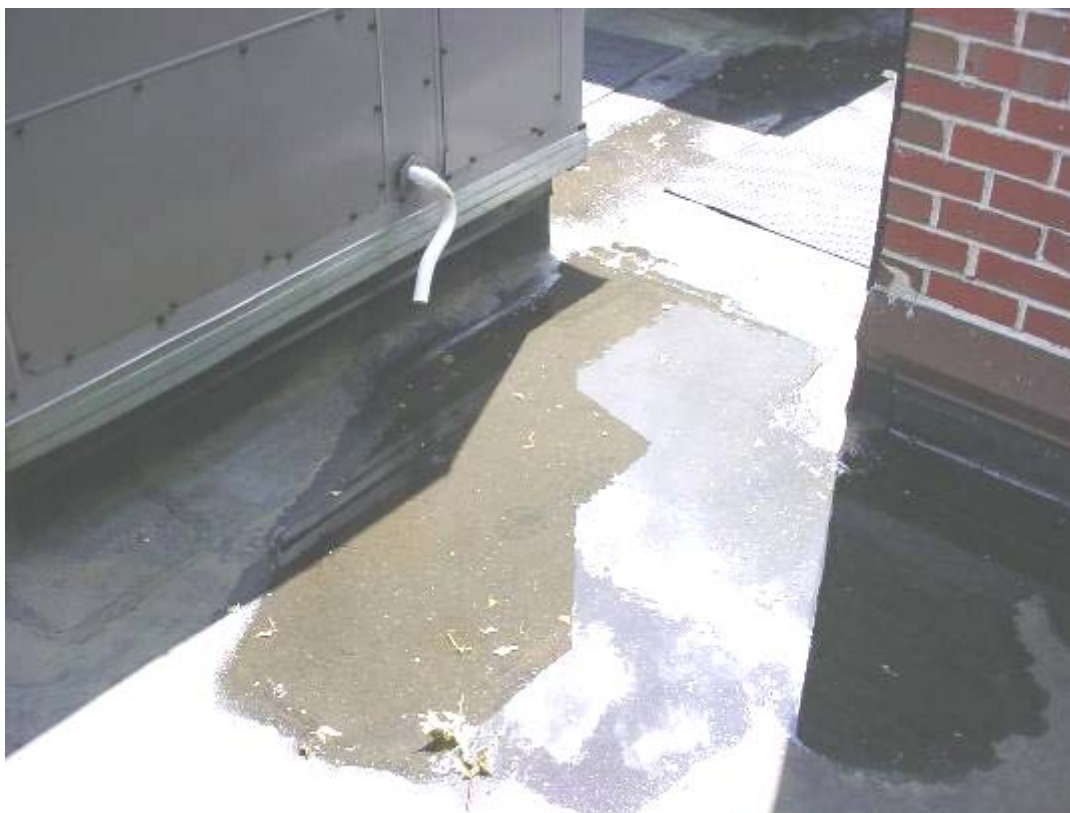
Picture 5

A number of areas had water damaged ceiling tiles. The likely cause of the water damage is a lack of appropriate water drainage from the roof. Settling of AHUs on the roof has created troughs in the roofing materials that accumulate water (Picture 5). Pooling water can cause damage to the roof membrane as water freezes and thaws during cold weather. Seams may open in the roof membrane, resulting in water damaged ceiling tiles. Water-damaged ceiling tiles can provide a source of mold and should be replaced after a leak is discovered and repaired.

Accumulated Water on Roof of 1997 Addition

4. Extend rooftop AHU condensation drains to terminate near roof drains.
5. Repair damage to roof membrane as needed.
6. Install drains for attic crawlspace drip pans.

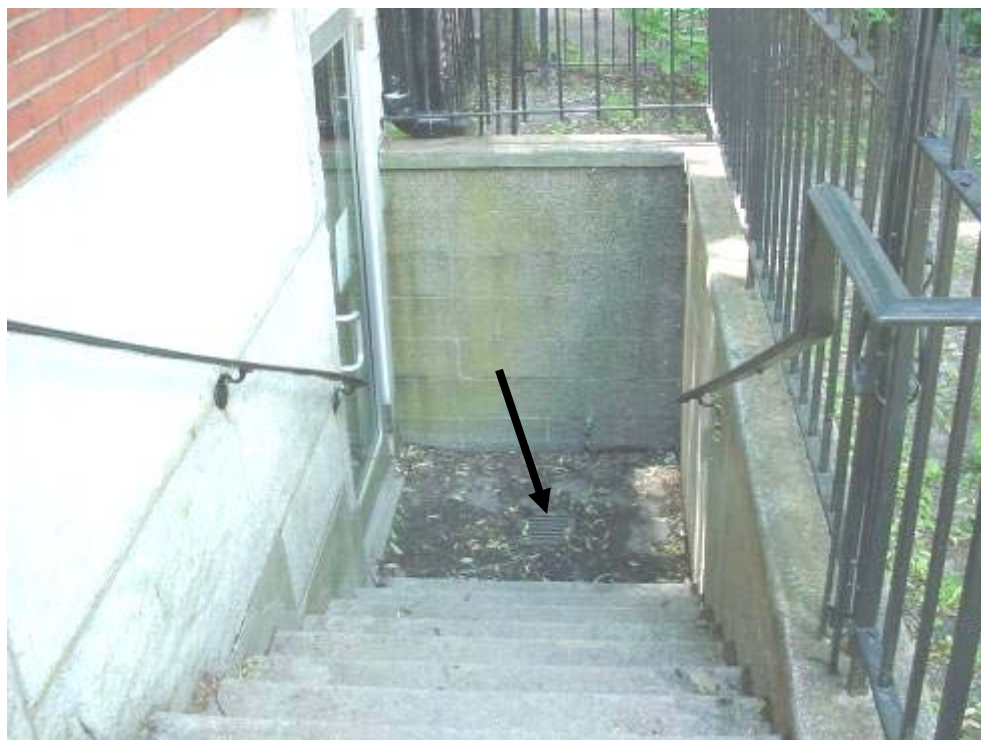
Picture 6

The 1940 wing contains a below grade entrance (Picture 6) equipped with a drain that has either become clogged with debris or may not be of sufficient capacity to remove water during heavy rain. Water from this location has reportedly penetrated through the exterior door to moisten gypsum wallboard (GW) and carpeting. Flood water from drains

Below Grade Entrance, Note Drain at Bottom

2. Replace carpeting with a non-porous material (e.g., non-slip tile) in areas subject to repeated water damage.
3. Clean drain in below grade entrance regularly to ensure proper drainage.

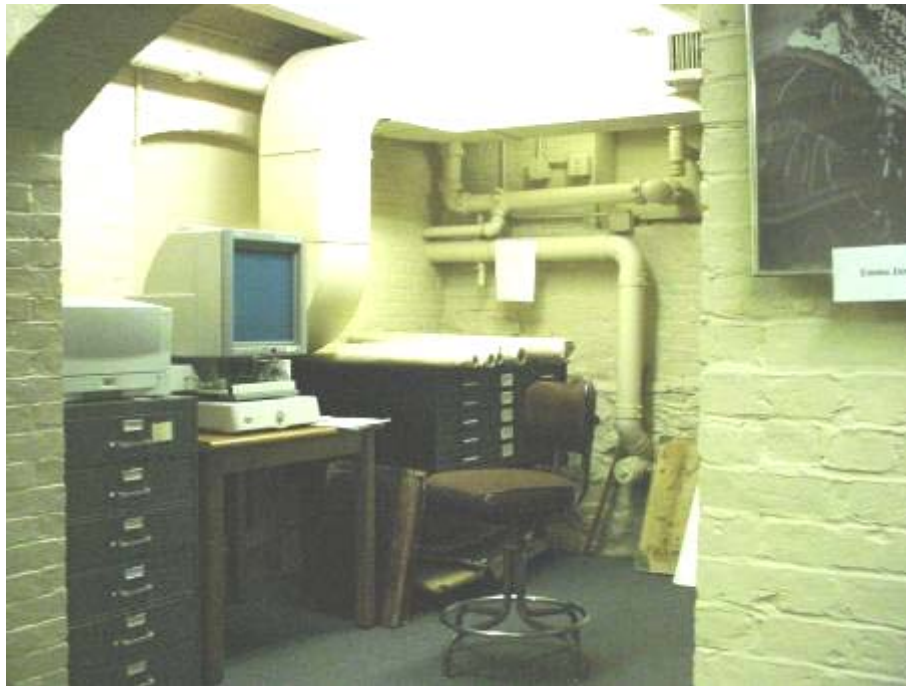
Picture 7

A musty odor was detected upon entering the Archive room, which is constructed like a vault (Picture 7). In general, vaults are designed to protect stored records in the case of fire by having no communication with the general HVAC system or are equipped with a separate dedicated system that ventilates the vault only. It appears that the Archive room is connected to its own HVAC system (Picture 8). Due to the age of the original building where the Archive room is located, it is highly unlikely that a vapor barrier exists beneath the floor which would make it prone to condensation. When warm, moist air passes over a surface that is colder than the air, water condensation can collect on the cold surface. Over time, water droplets can form, which can moisten porous, carbon containing materials (e.g., paper and cardboard) to produce mold growth. Since the floor is in contact with soil beneath the building, the temperature of the floor is likely below the dew point, which would moisten the carpet and likely the GW beneath the plastic coving on the wall. This condition may also result in chronic moistening of the document collection in the Archive room, which may result in mold growth.

The Archive

A decision should be made concerning the materials stored in the Archive room. Folders, documents, books and other stored materials if moistened by the HVAC system will continue to be a source of mold associated particulates. In this case, ventilation alone cannot serve to reduce or eliminate mold growth in these materials. As an initial step, options concerning the preservation of materials stored in this area should be considered. Since many of these materials appear to be historical records, an evaluation concerning disposition of these materials must be made. Porous materials that are judged not worthy of preservation, restoration or transfer to another media (e.g., microfiche or computer

scanning) should be discarded. Where stored materials are to be preserved, restored or otherwise handled, an evaluation should be done by a professional book/records conservator. This process can be rather expensive, and may be considered for conservation of irreplaceable documents that are colonized with mold. Due to the cost of book conservation, disposal or replacement of moldy materials may be the most economically feasible option.

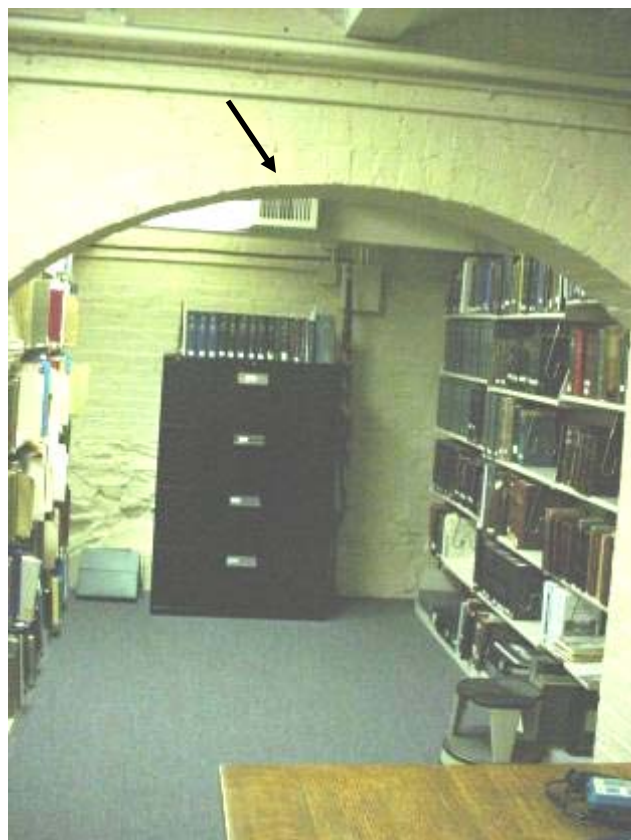
Picture 8

Fresh Air Diffuser of Archive HVAC System

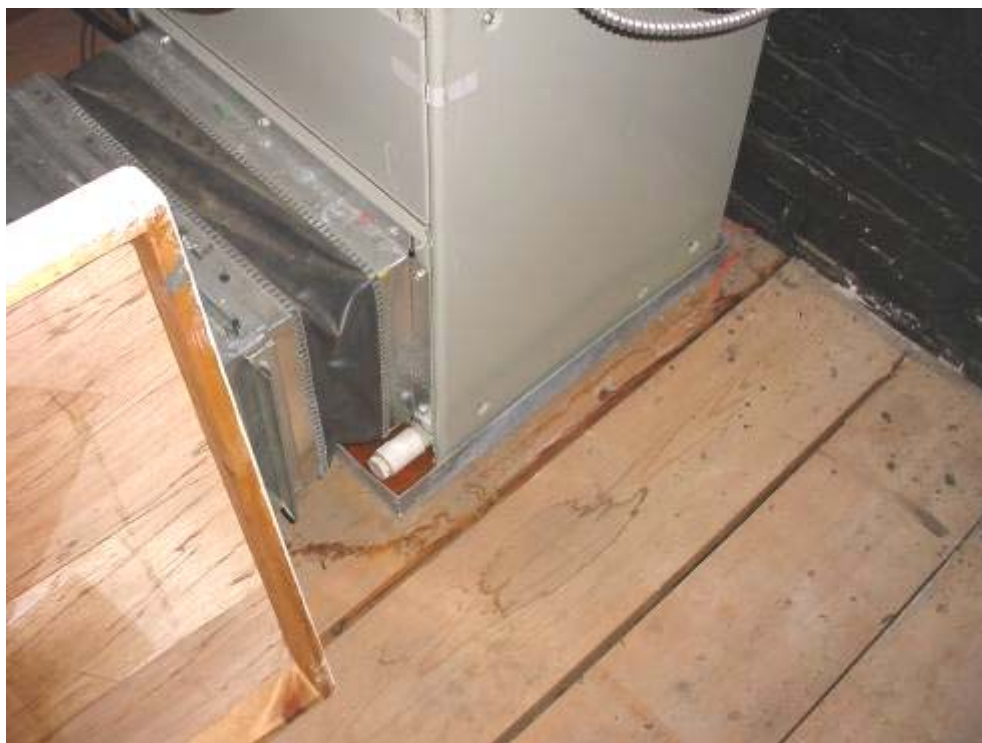
Picture 9

HVAC system equipment is located in an attic crawlspace above the 1940 wing. Inside this space are two AHUs that have drip pans that do not drain (Picture 9). The surface of each drip pan is severely corroded. Standing water in drip pans can serve as a medium for mold growth. If mold growth occurs, spores and odors can be transported to occupied areas of the building via the HVAC system.

Drain Pans in Attic Crawlspace above 1940 Wing

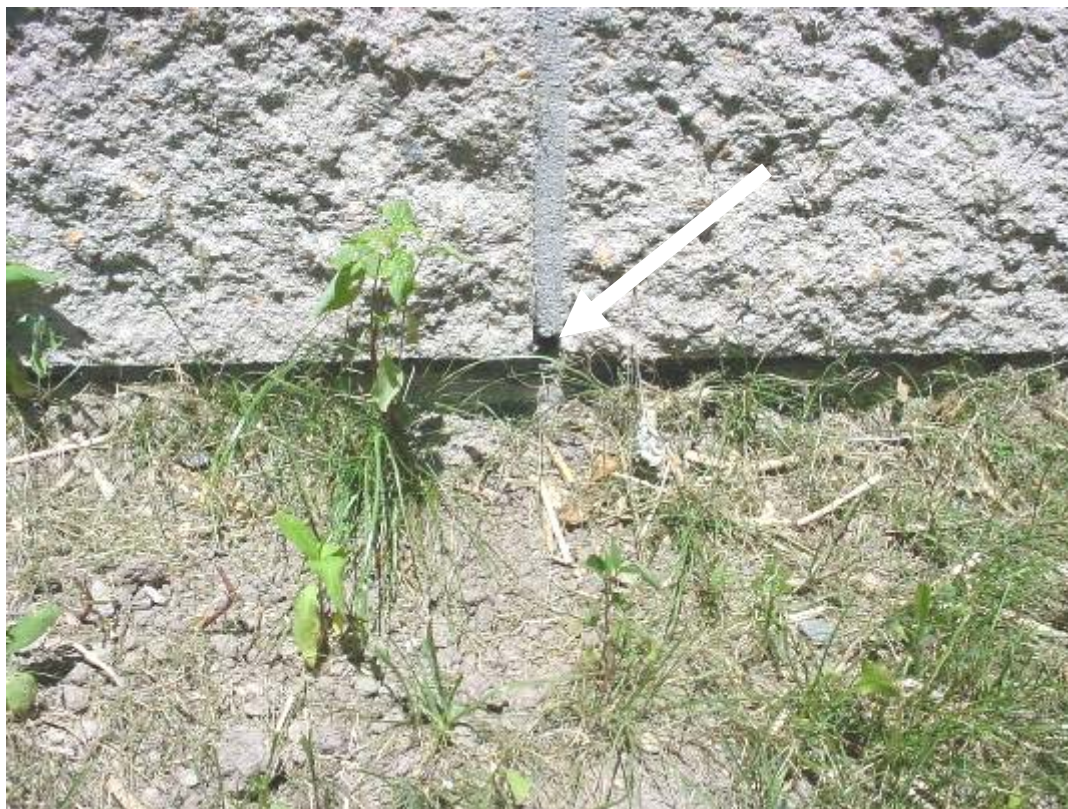
Picture 10

Of note along the exterior of the building were weep holes installed in the base of the exterior curtain wall of the new wing (Picture 10). Exterior wall systems should be designed to prevent moisture penetration into the building interior. An exterior wall system should consist of an exterior curtain wall. Behind the curtain wall is an air space that allows for water to drain downward and for the exterior cladding system to dry. In order to allow for water to drain from the exterior brick system, a series of weep holes is customarily installed in the exterior wall, at or near the foundation slab/exterior wall system junction. Weep holes allow for accumulated water to drain from a wall system (Dalzell, 1955). Opposite the exterior wall and across the air space is a continuous, water-resistant material adhered to the back up wall that forms the drainage plane.

Weep Holes in Wall, 1997 Wing

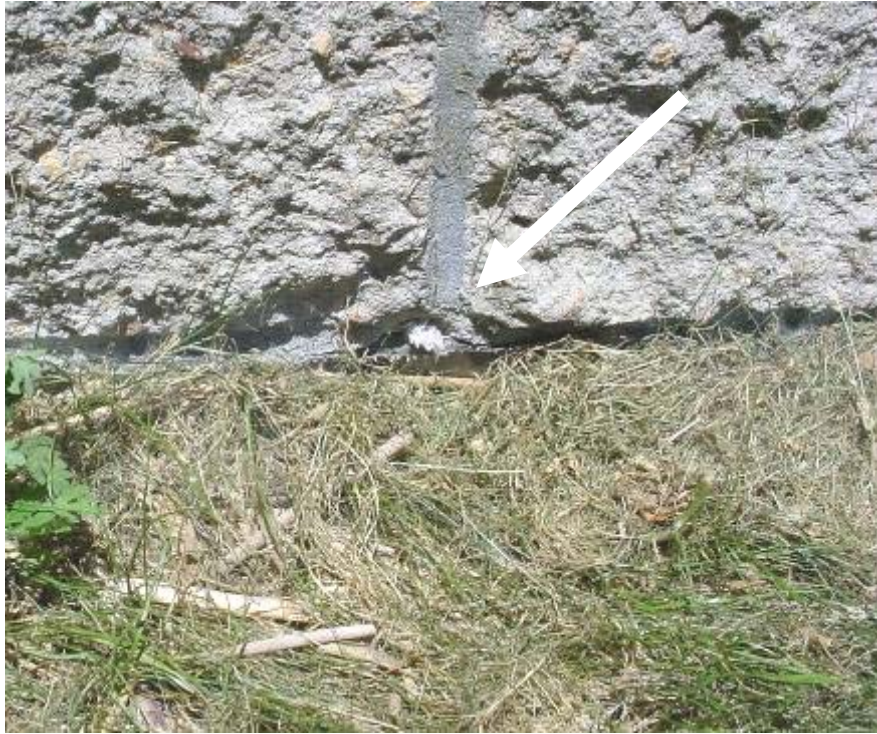
Picture 11

BEH staff identified a series of blocked weep holes in the exterior brick wall of the 1997 addition. Weep holes were plugged with wicks (Picture 11). “[U]se [of] ropes or tubes for weep [hole]s” is not recommended (Nelson, 1999). Without appropriate drainage, moisture can build up inside the wall’s drainage plane, resulting in increased water/moisture problems in the exterior wall.

Weep Hole Plugged With Wick

7. Remove wicks from weep holes. Insert appropriate screen material into weep holes to prevent insect entry into wall cavity.
8. For buildings in New England, periods of low relative humidity during the winter are often unavoidable. Therefore, scrupulous cleaning practices should be adopted to minimize common indoor air contaminants whose irritant effects can be

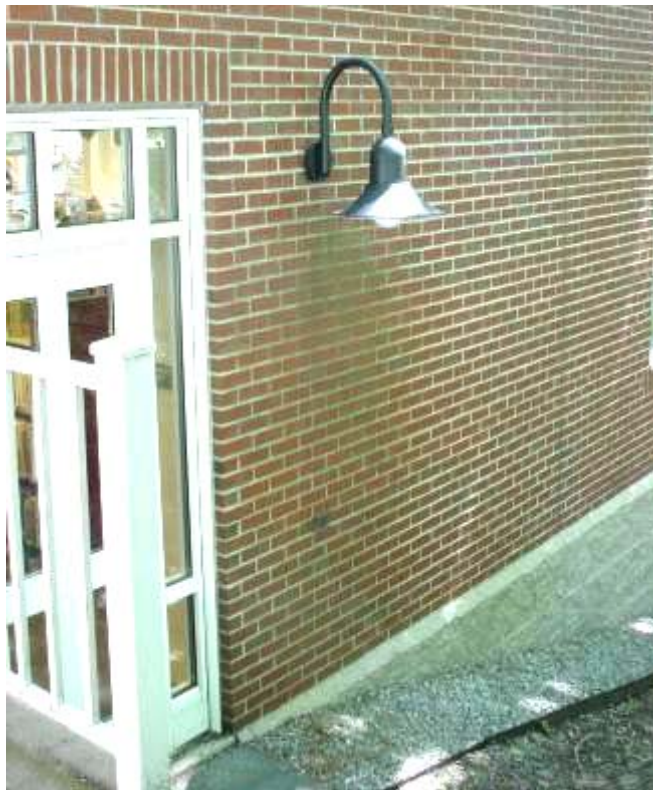
Picture 12

The exterior wall has an area beneath a light fixture that is covered with moss (Picture 12). Moss is a sign of chronic dampness and can hold moisture against brick to accelerate decomposition of the curtain wall.

Water Damage/Moss Growth to Exterior Wall beneath Light Fixture

9. Examine methods to redirect water moistening brick below light fixture (Picture 12).
10. Refer to resource manuals and other related indoor air quality documents for further building-wide evaluations and advice on maintaining public buildings. These materials are located on the MDPH's website at: http://mass.gov/dph/indoor_air.
